Condition Survey

Report verified by technicians from **REVICASA**

Calle Andalucía, 75, 1ºC

2011

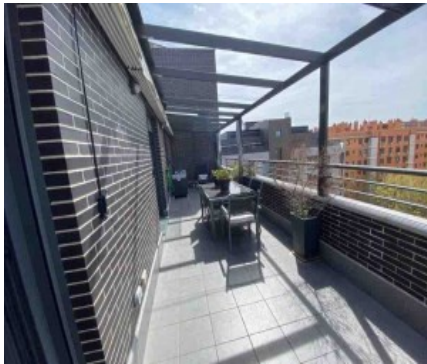
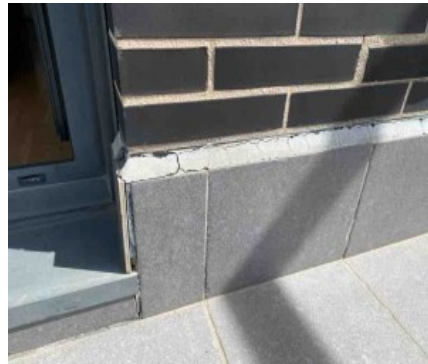
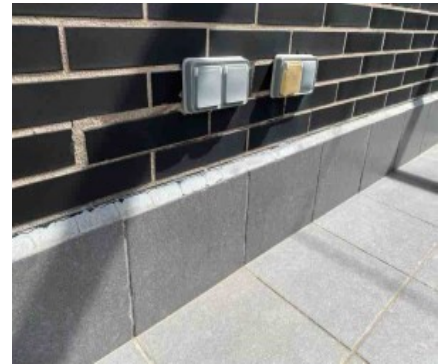
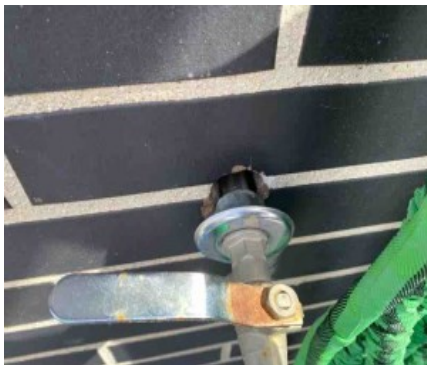
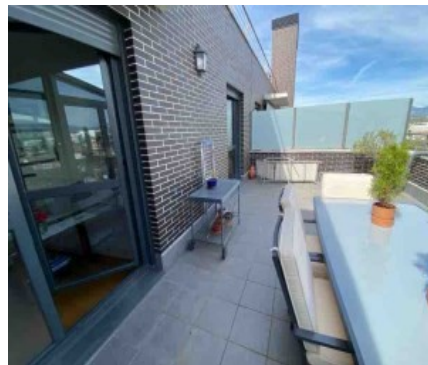
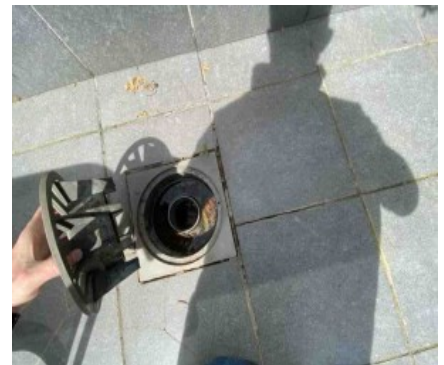
TERRACES

COMMENT: Outdoor terraces require simple maintenance such as cleaning the sealing of the base that protects the waterproofing to avoid possible water seepage and further deterioration of the waterproofing.

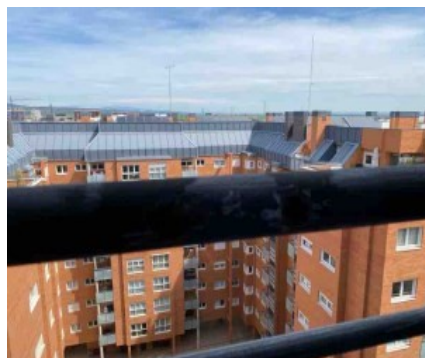
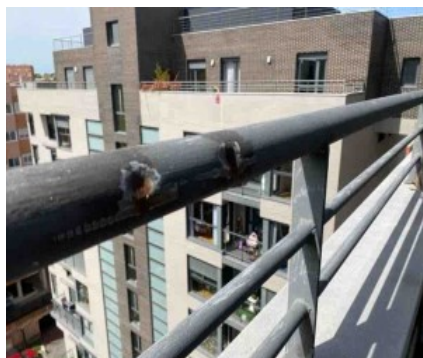
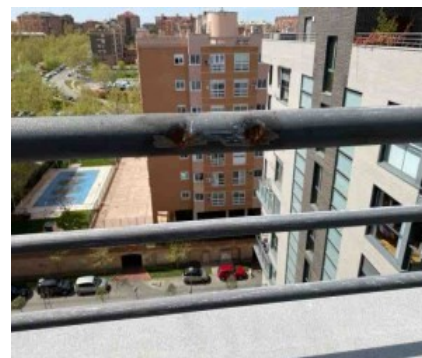
COMMENT: The terrace railing shows signs of wear and corrosion, as well as two points where the railing is broken.

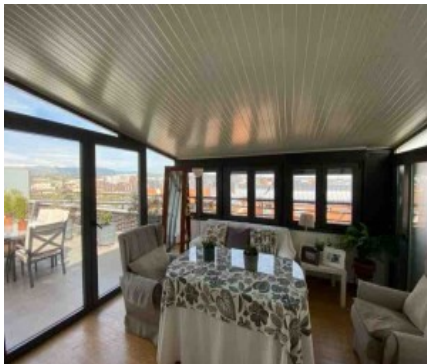
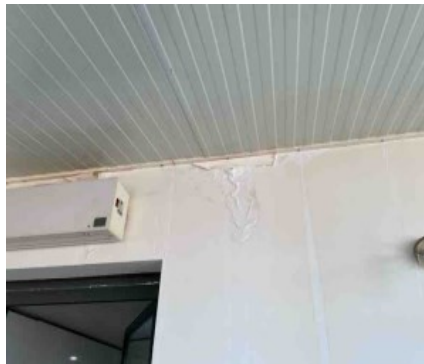
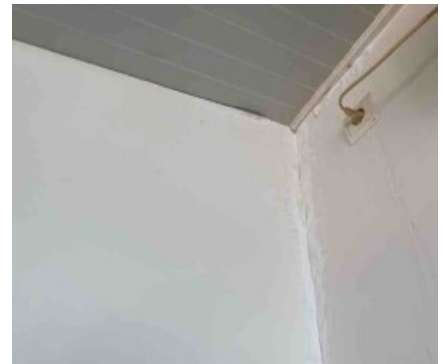
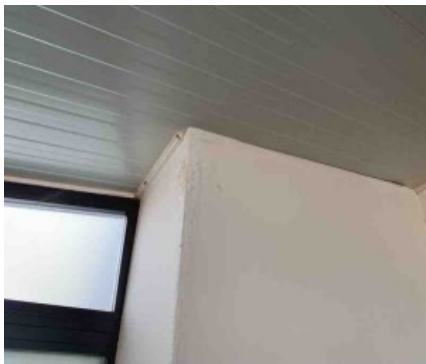
COMMENT: The roof of the terrace enclosed in a later renovation is the critical point, as there is evidence of leaking dampness in the ceiling and walls. This is believed to be due to poor resolution of the junction between the new roof and the façade of the building.

To prevent this problem from continuing and even increasing, in the opinion of the technician who drafted this report, the waterproofing of the joint between the façade and the roof should first be repaired with a layer of bituminous paint and then a duly sealed lacquered sheet should be placed at the joint to act as a bib.

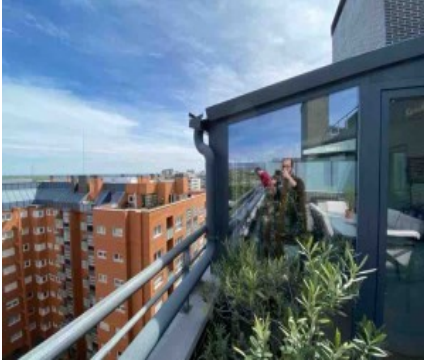
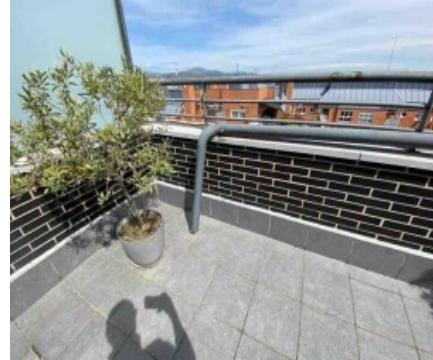
COMMENT: The storm water drainage is closed.

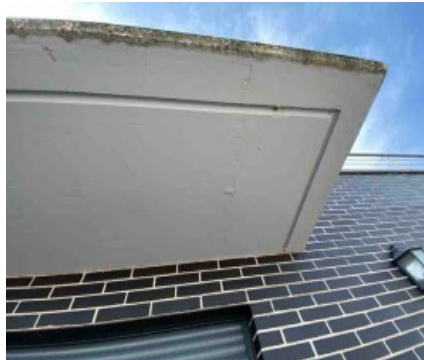
ALEROS

COMMENT: Signs of deterioration to the finish of the canopy have been observed, although these are not considered serious as they do not affect structural elements.

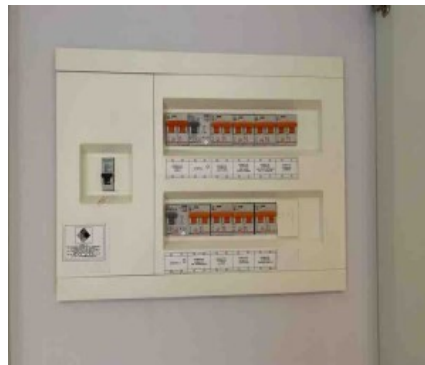
The electrical installation is in perfect condition and operational, as well as having the appropriate circuits for its surface area and independence from the different appliances and areas of the home.

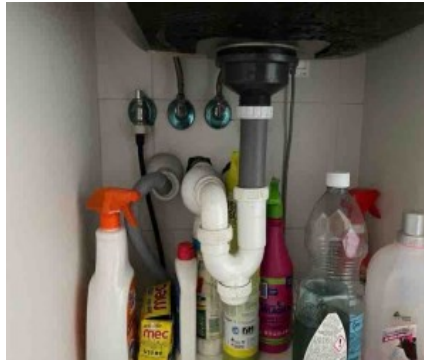
COMMENT: The plumbing in the dwelling is operational and the water pressure, both hot and cold, is adequate. It should be noted that the water intakes for each appliance are very stiff, probably due to lack of use.

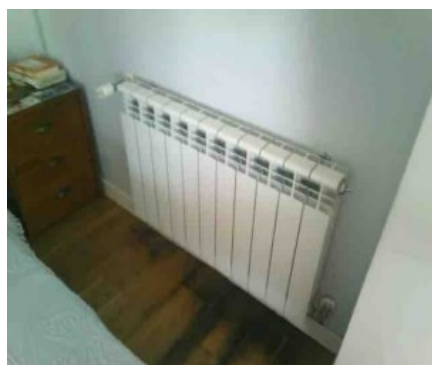
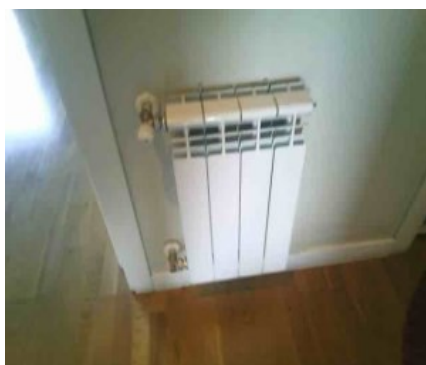
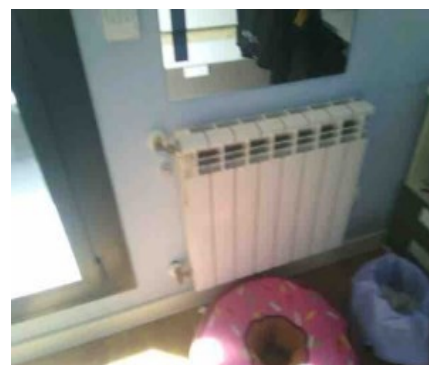
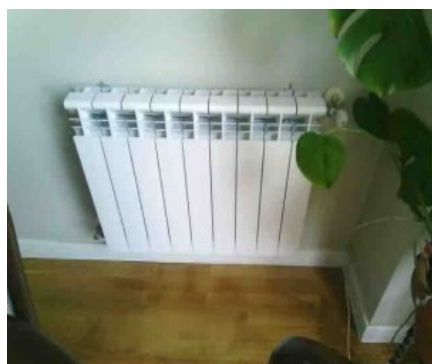
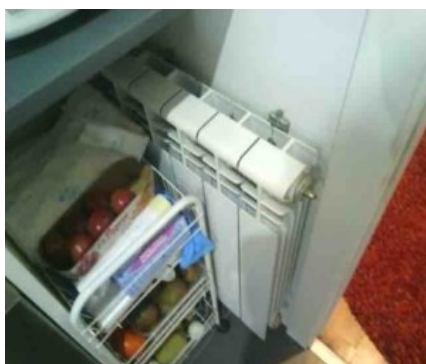
COMMENT: Part of the floor was detected under a deteriorated radiator, probably due to a leak, which was repaired at the time and no longer persists, as well as a partially burnt radiator on one side.

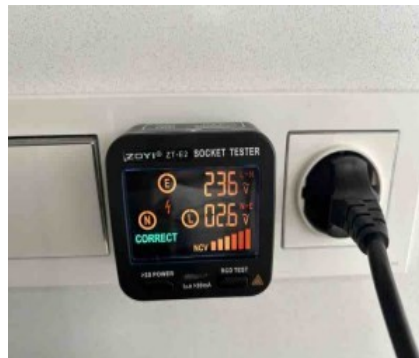
COMMENT: The kitchen sockets have been checked for correct operation, are earthed and the voltage is correct.

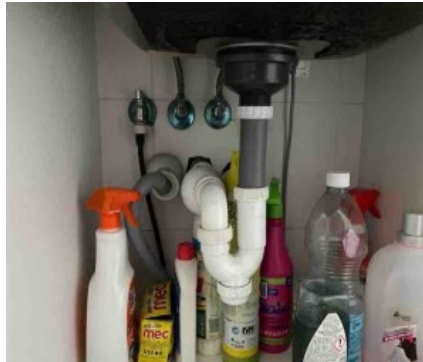
STATE OF WATER INTAKES

COMMENT: The water intakes at the kitchen sink are very hard and cannot be manipulated, due to little use, replacement is recommended.

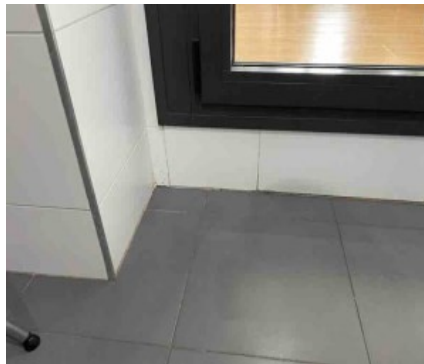
COMMENT: It is recommended to sanitise the tiling joints.

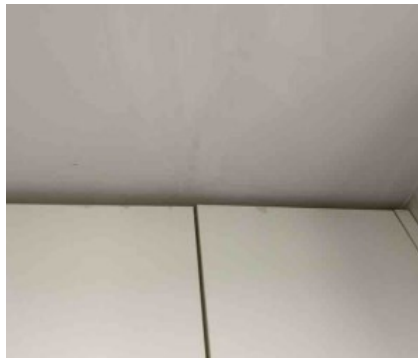
COMMENT: Signs of dampness have been observed in the kitchen ceiling, it is recommended to paint and renovate the kitchen ceiling.

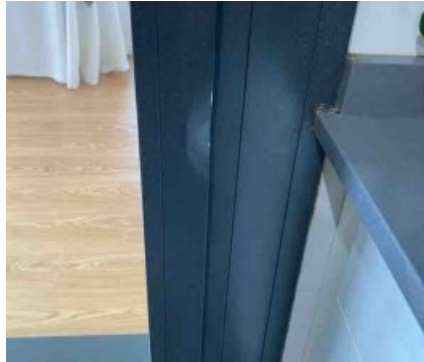
DOORS

COMMENT: Kitchen door knocked.

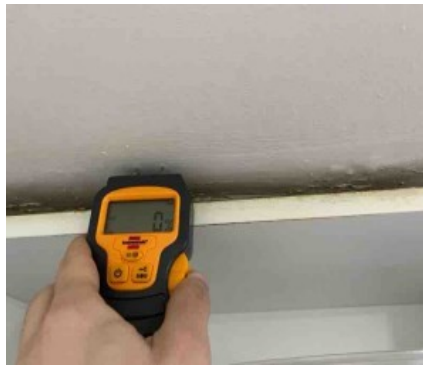
COMMENT: The signs of dampness in the ceiling have been tested for hygrometry, the results of which are low, so this dampness is not active.

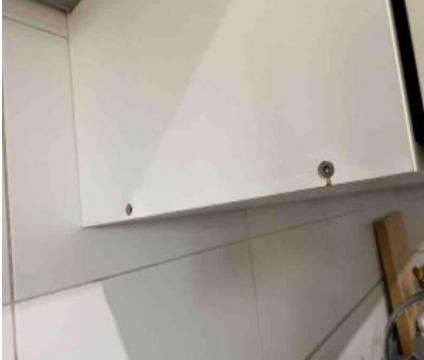
COMMENT: Some deterioration has been observed in the fixed furniture, but it is still functional.

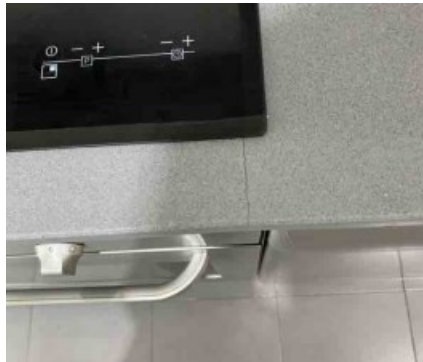
ENCIMERA

COMMENT: There is a small crack in the ceramic hob area of the worktop.

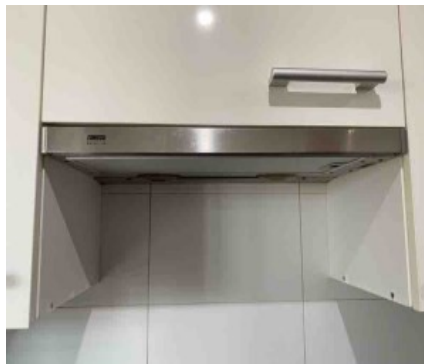
The extractor campaign is not working so it needs to be replaced and this is what has been assessed in this section.

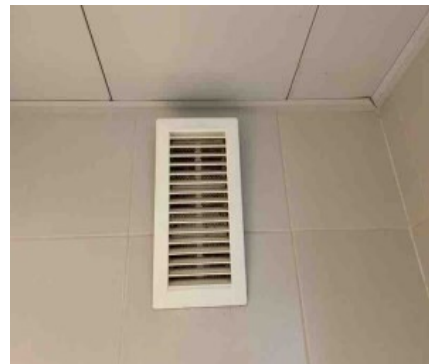
COMMENT: A grille needs to be fitted in the missing hole in the main bathroom and the one in the secondary bathroom needs to be tightened.

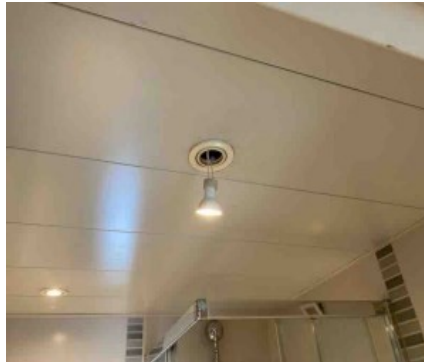
COMMENT: In the secondary bathroom one of the luminaires is loose so it needs to be fitted correctly.

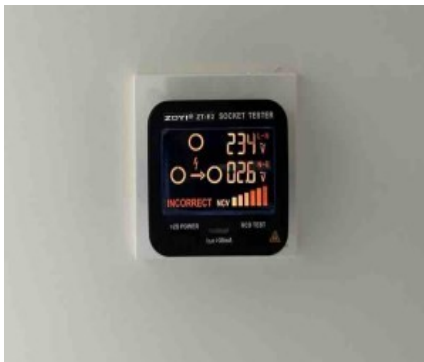
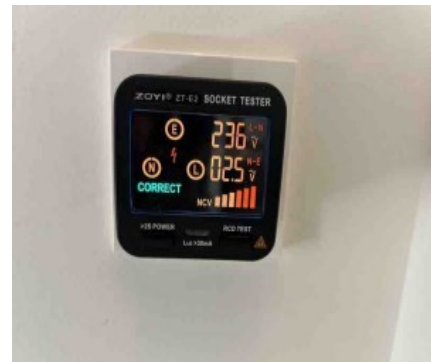
COMMENT: It has been detected that one of the sockets has no current, while the rest are working properly, are earthed and have adequate voltage.

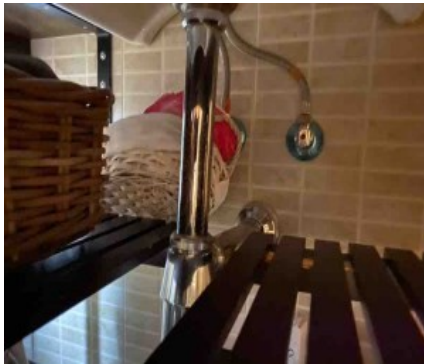
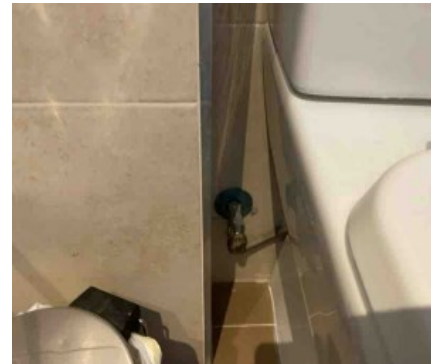
COMMENT: As in the kitchen, the water intakes of sinks and toilets are also not practicable due to lack of use, so replacement is recommended.

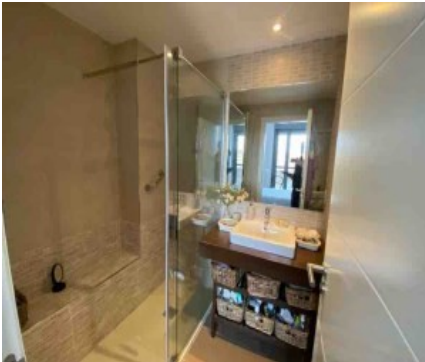
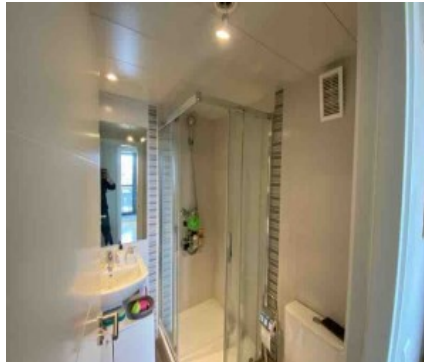
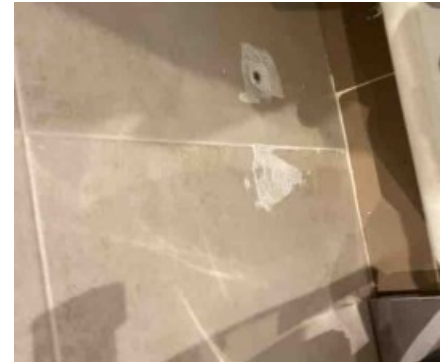
COMMENT: The bathrooms in the dwelling have signs of wear and tear and deterioration especially in ceramic finishes on walls.

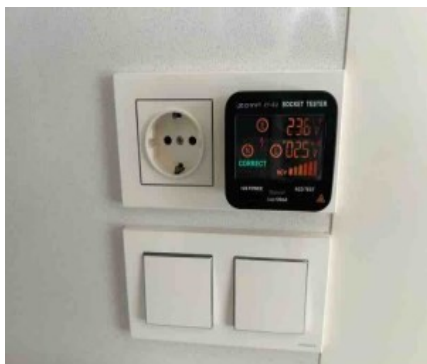
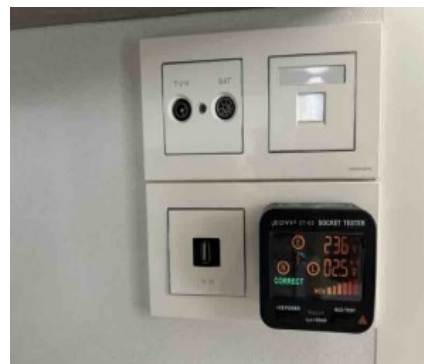
COMMENT: The sockets have been tested and are working properly, are earthed and have adequate voltage.

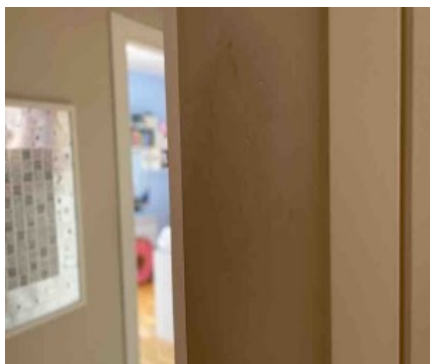
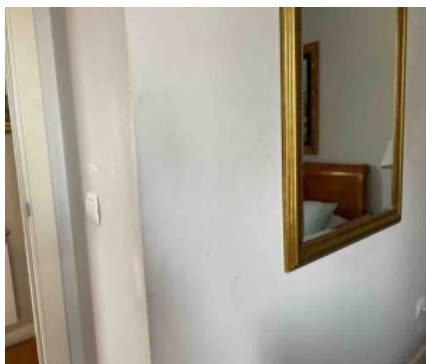
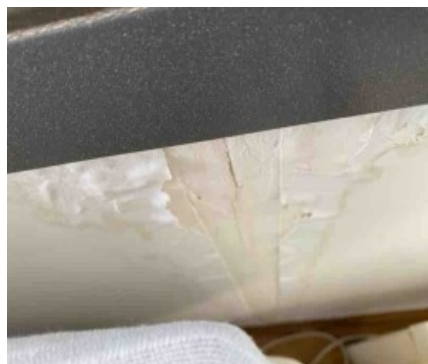
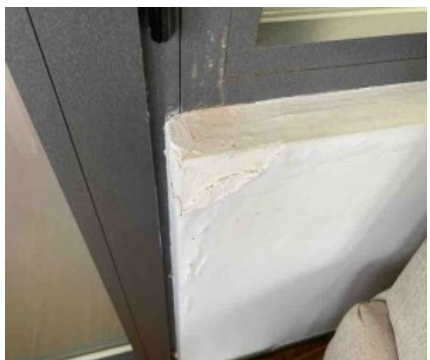
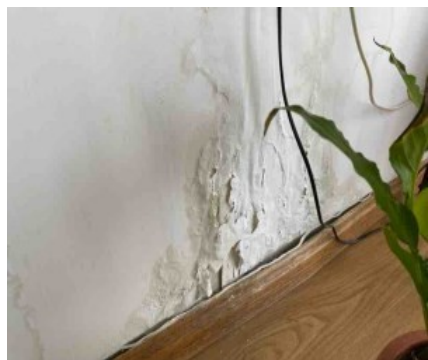
The rooms of the property are in good condition, having signs of normal wear and tear from use and the passage of time.

It is recommended to paint the entire property, as there are signs of damp and deterioration in several areas of the property. The complete painting of the property will be assessed.

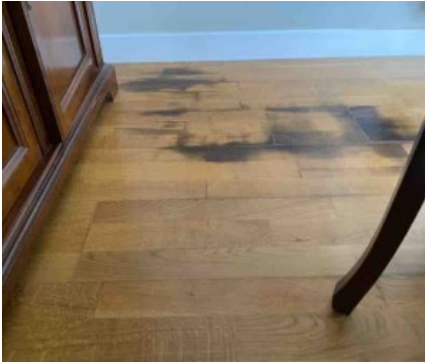
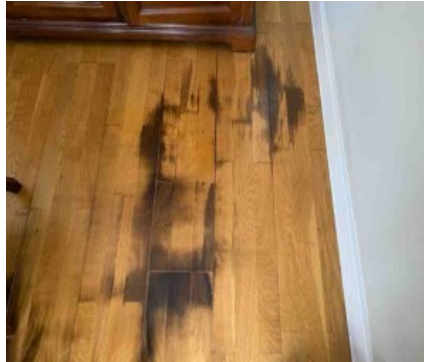
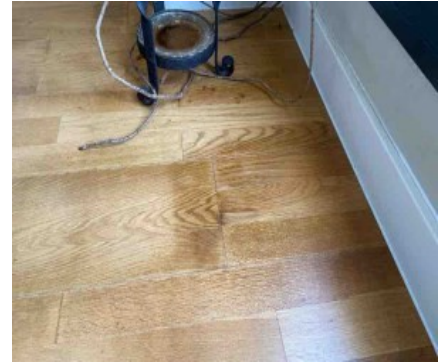
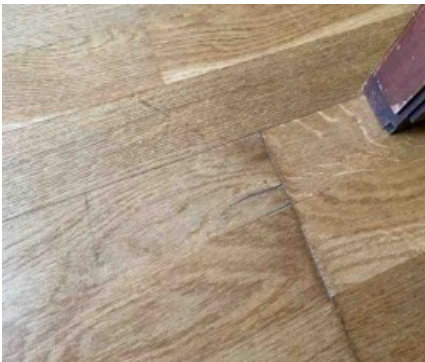
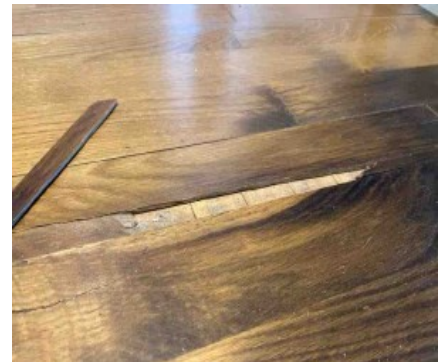
COMMENT: Several damp marks have been observed on the floor of the property, but none of them are active and it seems to have been a one-off problem. It is therefore considered that the flooring in the property should be replaced with a medium quality floating floor.

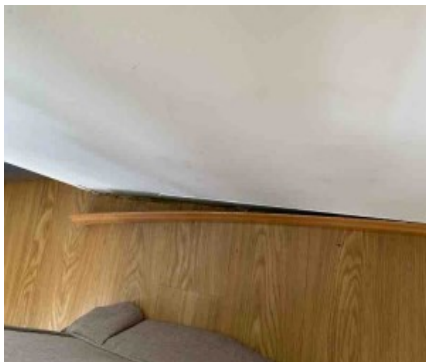
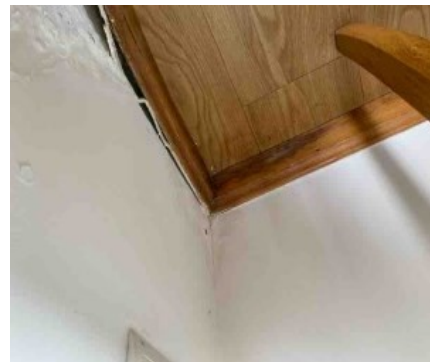
RODAPIÉS	<input type="radio"/> No existe	<input type="radio"/> Crítico	<input checked="" type="radio"/> Mal	<input type="radio"/> Aceptable	<input type="radio"/> Bien
----------	---------------------------------	-------------------------------	--------------------------------------	---------------------------------	----------------------------

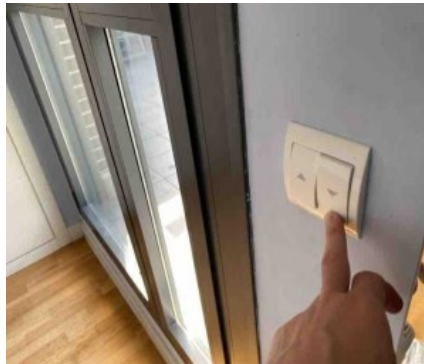
COMMENT: The operation of the motorised blinds is acceptable, although it must be taken into account that to operate them you have to hold down the corresponding button and there are some that make quite a lot of noise and give the impression of getting stuck, although they never block. Cleaning and maintenance of the mechanisms is recommended to ensure good operation.

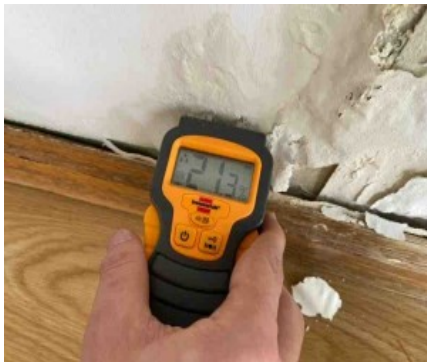
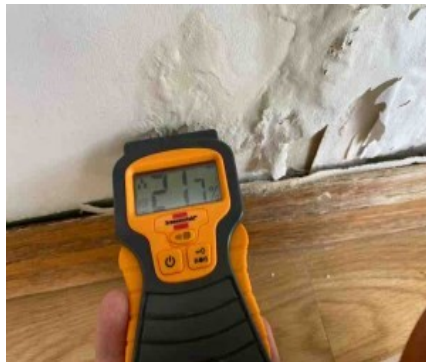
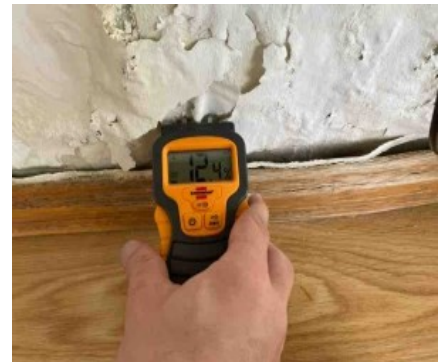
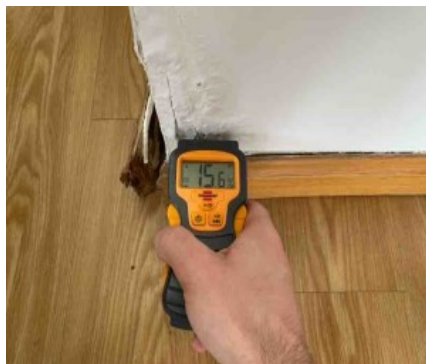
COMMENT: The critical point of the house is the active humidities, as verified with the hygrometer, found in the enclosed terrace. This problem is largely due to the poor execution of the roof and the enclosure of the terrace extension, as already described in the roof section. The repair of the deteriorated finishes of the enclosed terrace is assessed.

The most serious problem detected is the active dampness in the area of the terrace extension, due, according to the technician, to a bad execution of the enclosure and its meeting with the façade. Therefore, the client will have to assess the current situation of the house and the repair costs.

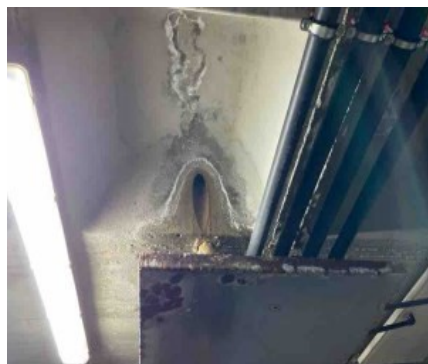
COMMENT: Metal and plastic drainage trays have been found in the garage to collect any leaks that may occur in the downpipes. Although this solution can prevent water from reaching the ground, the metal tray is rusted and shows signs of corrosion. The maintenance of these trays is the responsibility of the owners' association and in the event that it could damage a parking space, another solution should be sought.
